Manhole Inspection Summary

Manhole # S05CC1005MH

Location Address: **3836 SEQUOIA AVE**

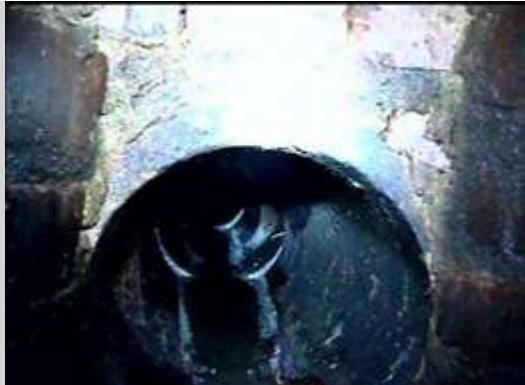
12 O'Clock Outflow

8 in. Circular Gravity Sewer
Pipe Out @ 12 O'Clock

Pipe Material: **Clay** ☐ Pipe Lined

Invert Depth: **7.75** (ft.) Flow Characteristics: **None**

Deposits: ☒ None ☐ Mud ☐ Sludge ☐ Debris ☐ Grease

Infiltration: **None** Pipe Seal Cond: **Sound**

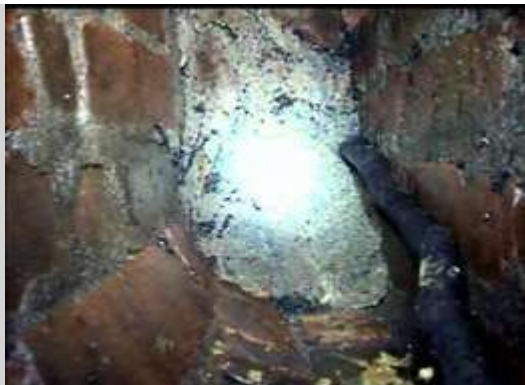
4 O'Clock Inflow

6 in. Circular Gravity Sewer
Pipe In @ 4 O'Clock

Pipe Material: **Clay** ☐ Pipe Lined

Infiltration: **None** Pipe Seal Cond: **Sound**
